Corrosion in the Petroleum Industry

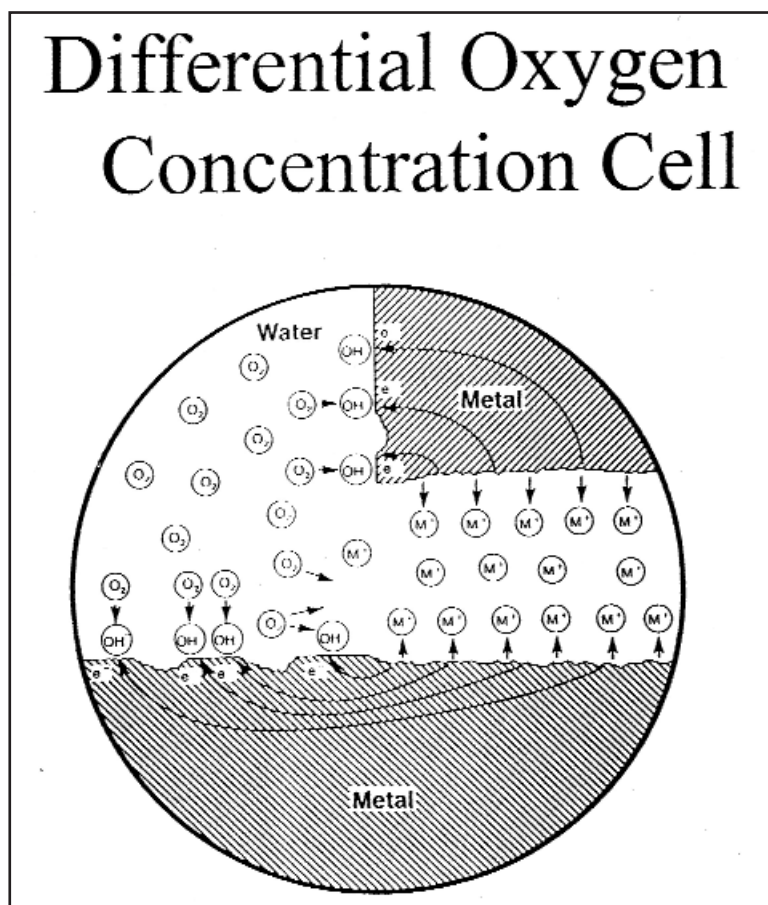
Figure IX-44:
(Source: *The Nalco Guide to Cooling Water Systems Failure Analysis*)

Initial corrosion was caused by the formation of differential oxygen concentration cells beneath occlusive deposit layers. A diagram of a differential oxygen concentration cell between contacting metal surfaces is shown in Figure IX-44. The water beneath an occlusive deposit or corrosion product layer or within a tight crevice between contacting metal surfaces becomes depleted in oxygen concentration. Consequently, the cathodic reaction in the corrosion cell could only occur where oxygen concentrations were higher, such as at breaks in the deposit layer, and on the outer surfaces of iron oxide layers and tubercles. The anodic reaction in the corrosion cell occurs within the oxygen depleted zone to produce metal dissolution. Metal ion leaks out of the oxygen depleted zone into the zone where oxygen concentration is high to produce iron oxide corrosion products. By this process, iron oxide tubercles form.

Concentration cell corrosion may be controlled by maintaining clean metal surfaces, both mechanically and through proper water treatment and corrosion inhibition. Corrosion may also be controlled by minimizing or eliminating low or stagnant flow, and by decreasing concentration of aggressive anions. If these measures cannot be taken, and/or if corrosion cannot be controlled, then the use of alternate materials or coatings may be considered.

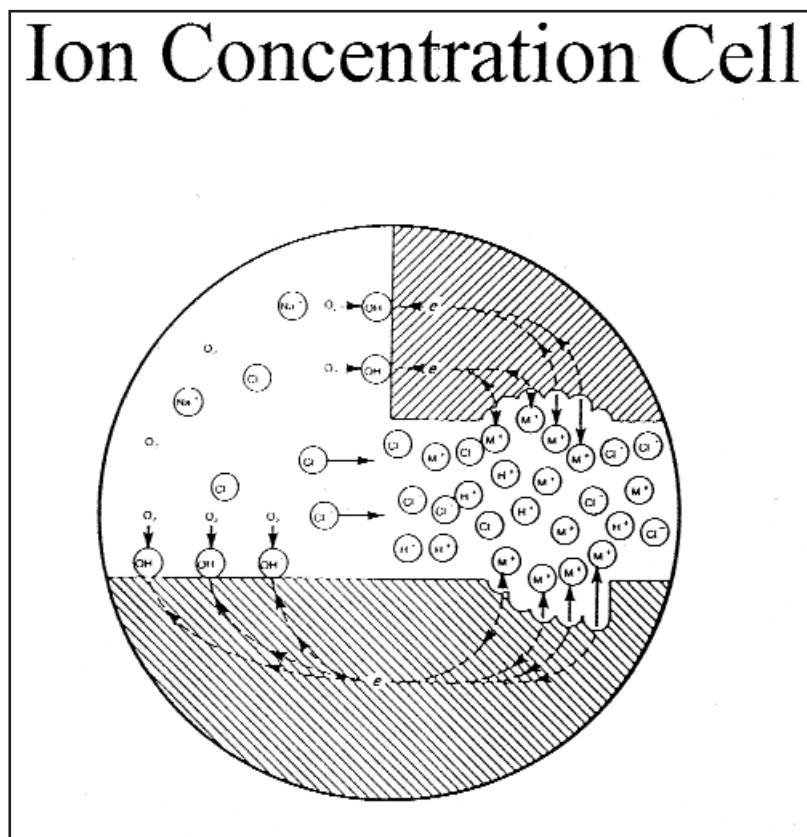
Figure IX-45:
(Source: *The Nalco Guide to Cooling Water Systems Failure Analysis*)

Ion concentration cells also may form beneath occlusive deposit and corrosion product layers, tubercles and between crevices (Figure IX-45). The positively charged metal ions within the occluded zones attract aggressive anions such as chloride, sulfate, and sulfide. Aggressive anion concentration may become several times that in the bulk water to produce locally acidic and highly corrosive environments. The acidic environments dissolve protective corrosion product layers and then the metal itself to produce rough-surfaced, undercut pits and depressions. Acid corrosion significantly accelerates metal loss. The reactions and corrosion products that may occur within an iron oxide tubercle are shown in Figure IX-46.
